# Case Study

## Zenith™ Amniotic Membrane

Case presented by Jacob Fassman, DPM; Podiatrist;  
Colorado Foot and Ankle; Colorado Springs, CO

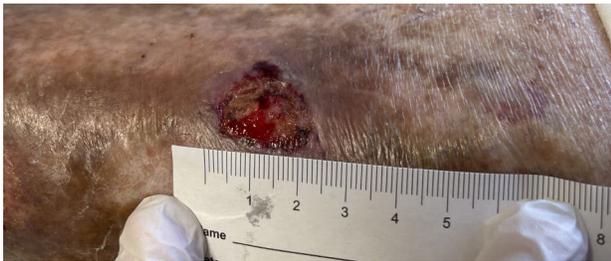
**WEEK 1** Debridement with application of 2 x 3 cm Zenith

Size: **2 x 1.5 x 0.1 cm**

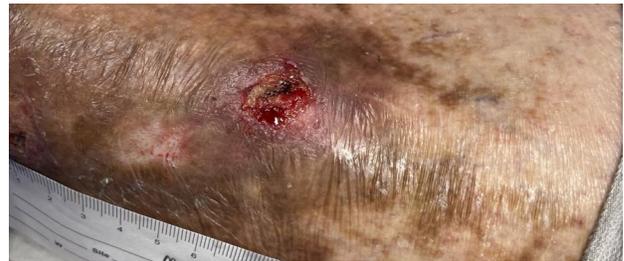
**WEEK 2** After debridement, application of 2 x 3 cm Zenith

Size: **1.6 x 1.3 x 0.1 cm** | Volume reduced: **31%**

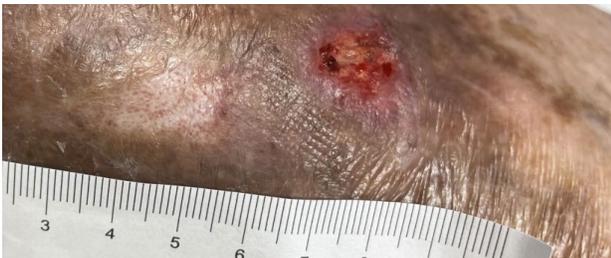
**WEEK 3** After debridement, application of 2 x 3 cm Zenith

Size: **1.3 x 0.9 x 0.1 cm** | Volume reduced: **44%**

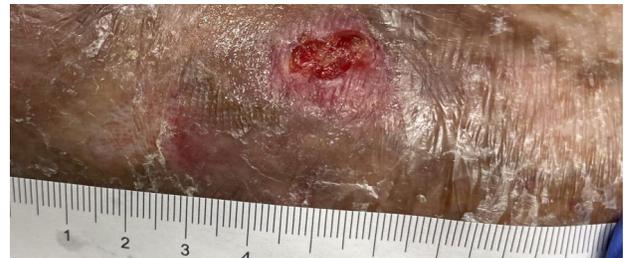
**WEEK 5** After additional Zenith in week 4, patient is improving; fifth 2 x 3 cm Zenith applied after debridement

Size: **1.2 x 0.5 x 0.1 cm** | Volume reduced: **52%**

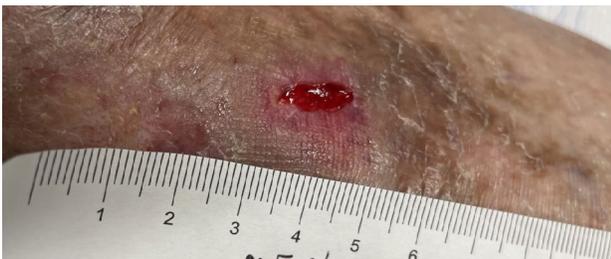
**WEEK 6** After debridement, application of 2 x 3 cm Zenith

Size: **1.3 x 0.3 x 0.1 cm** | Volume reduced: **35%**

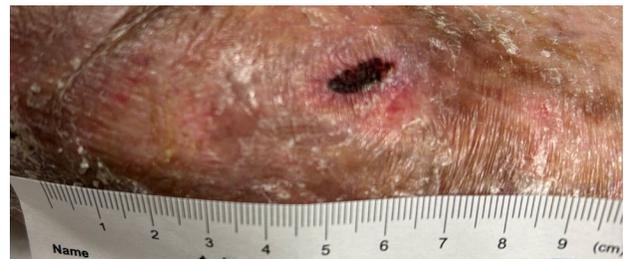
**WEEK 8** After additional Zenith application in week 7, wound healed

Size: **Wound resolved**
